PLYMOUTH SERVICE INFORMATION BULLETIN

Number 19-3

Date Mar. 2, 1960

SUBJECT: NEW POWER STEERING PUMP WITH LOAD REACTION BELT TENSIONER

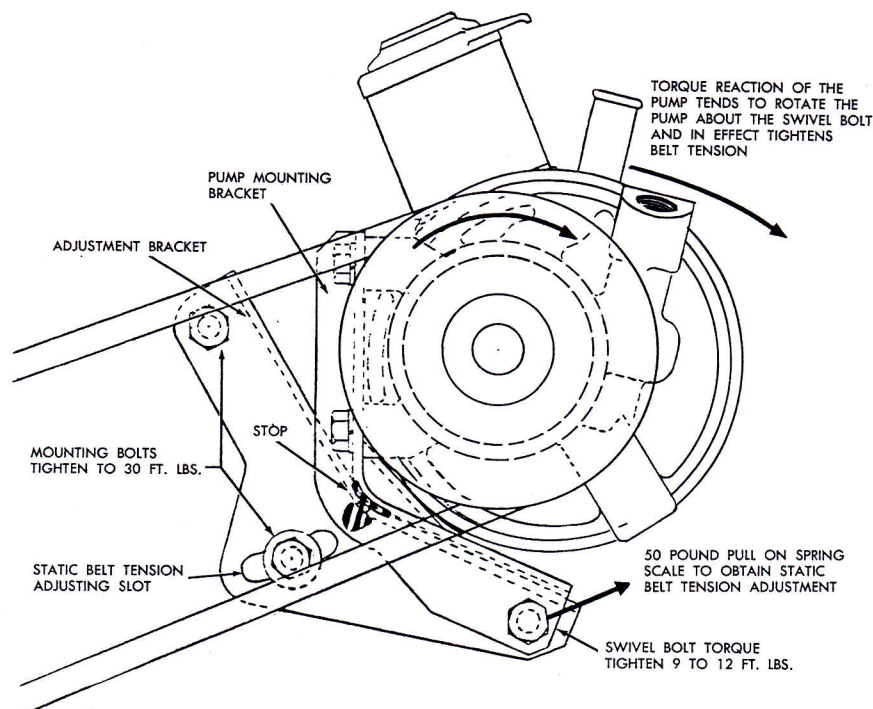
P-983-C

- (3) Pump is mounted on a flexible swivel-type mounting to enable the steering pump load to be increased when the torque reaction of the pump, acting through the mounting bracket and adjustment bracket, moves the pump outward and increases the belt tension to the required amount. This prevents belt slippage under all load conditions, and in effect, lengthens the belt and service life, see illustration.

Diagnosis: If a knocking condition is encountered at the bracket stop when the engine is running, it is an indication that the belt tension is too tight, or the belt is worn to the extent that the belt tension cannot be properly adjusted. Adjust the belt tension, or install a new belt if necessary.

If a belt squeal is encountered under heavy steering load (such as entering a curb-side parking space), it is an indication that the belt tension is too loose, or the belt is worn to the extent that the reaction bracket cannot properly adjust the belt tension. Adjust the belt tension or install a new belt if necessary.

Belt Adjustment: The belt tension is adjusted when the engine is stopped by loosening the adjustment bracket-to-engine mounting bolts, and exerting an outward pull of 50 lbs. on a spring scale at the swivel bolt. Then tighten the adjustment bracket mounting bolts. At this time the pump mounting bracket is resting against the stop. With the engine running, the pump load reaction will move the pump mounting bracket away from the stop. Approximately .030 in. shaft end play is normal.
