# SERVICE BULLETIN

No. 60-49

Engine  
Performance

All 1960  
Chrysler  
C-300F

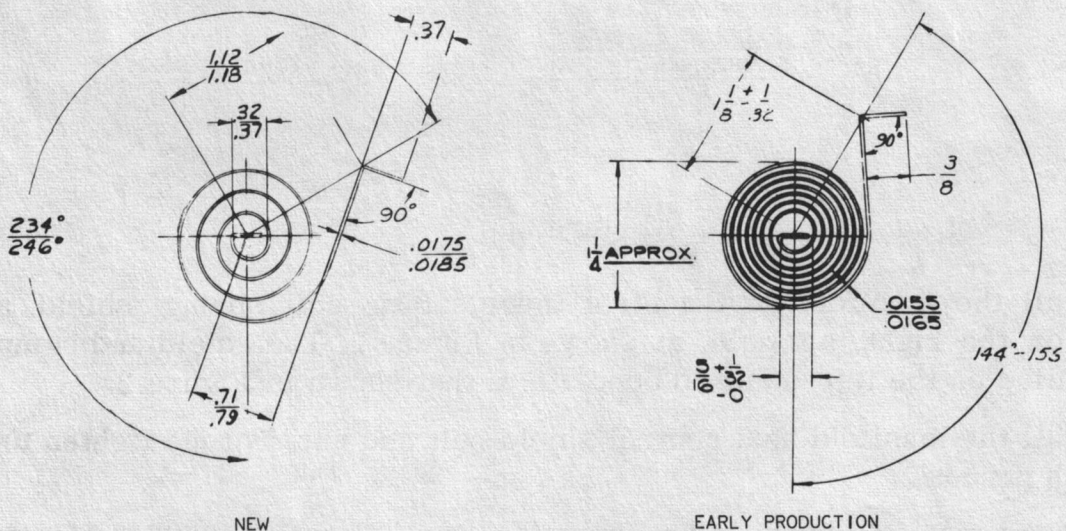
Figure 1

If you experience a condition of poor performance, loading up, rough engine operation, or possible spark plug fouling during engine warm-up, on 1960 Chrysler C-300F models, the information in this bulletin may be of assistance to you.

- (a) Inspect and test the operation of the manifold heat controls.
- (b) Inspect the manifold heat control thermostatic coil spring. If the spring has approximately (7) seven coils, remove the thermostatic coil spring and install a New Manifold Heat Control Thermostatic Coil Spring Part No. 2128933. This spring has approximately (5) five coils. See Figure 1.
