LETTER SERIES 300 TRANSMISSIONS

by George Riehl

SERVICE BULLETIN

Automatic
Transmission
Lubrication &
Servicing
Instructions

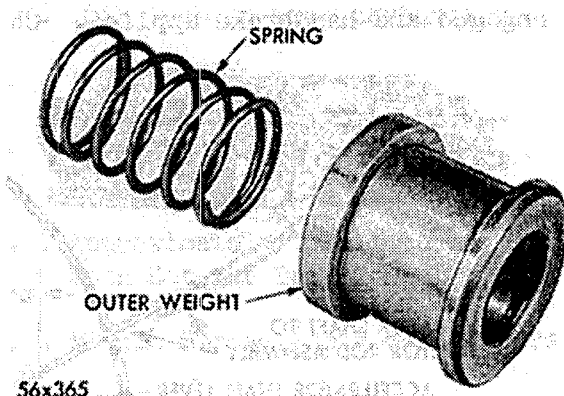
Fig. 11 - Transmission Governor Outer Weight and Spring

Should it ever become necessary to replace either the governor weights (inner or outer) and/or weight spring (Figure 11), it is essential that the following parts be used:

<u>Part Name</u>	<u>Part Number</u>
Outer Weight	1823726
Inner Weight	1636462
Spring	1823709

Be sure to recheck governor pressure. See Governor Pressure Chart - Next Paragraph.

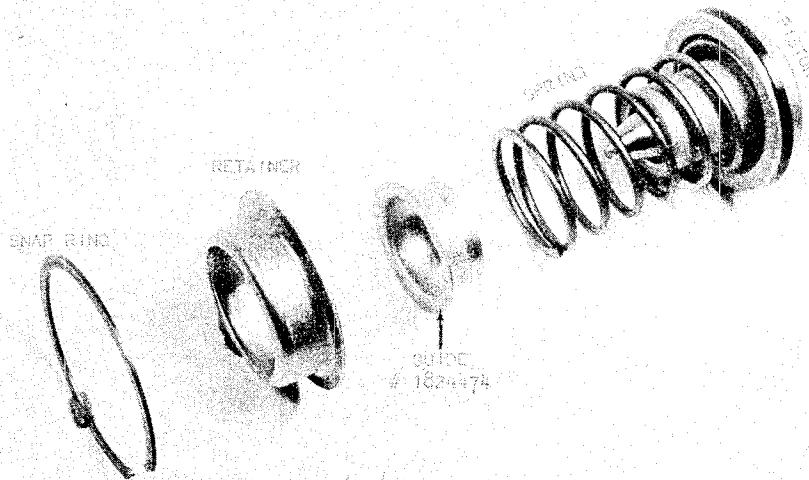
FIGURE 1

There is a possibility that on some 1957 Torque-Flite Transmissions built prior to code letter "F" that the reverse servo will cock over and subsequently miss the pilot hole on the reverse band lever.

Whenever there is a failure of the reverse servo piston, Reverse Servo Piston Guide Part No. 1824474 must be installed to prevent a recurrence of the failure. (See Figure 1)

Further, at any time a 1957 Torque-Flite Transmission built prior to code letter "F" is disassembled for service for any reason, the piston guide No. 1824474 should be installed.
